HEROES - CHERNOBYL

VICTIMS 27

photographic
documentation of
damage that requires
urgent repair

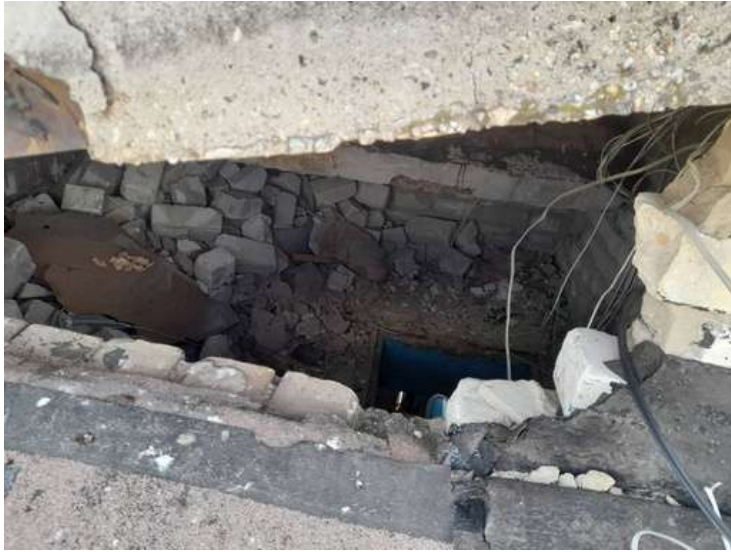
damage to roof structures

Exterior walls, facade:

- damaged wall (access to the roof) - 8m²
- roof (roof) damage to the roof slabs -12m²
- damage to the roof -45m²

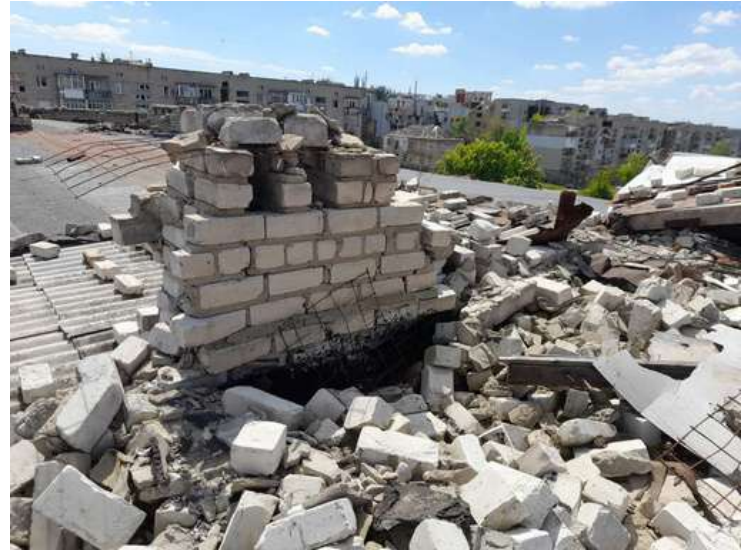
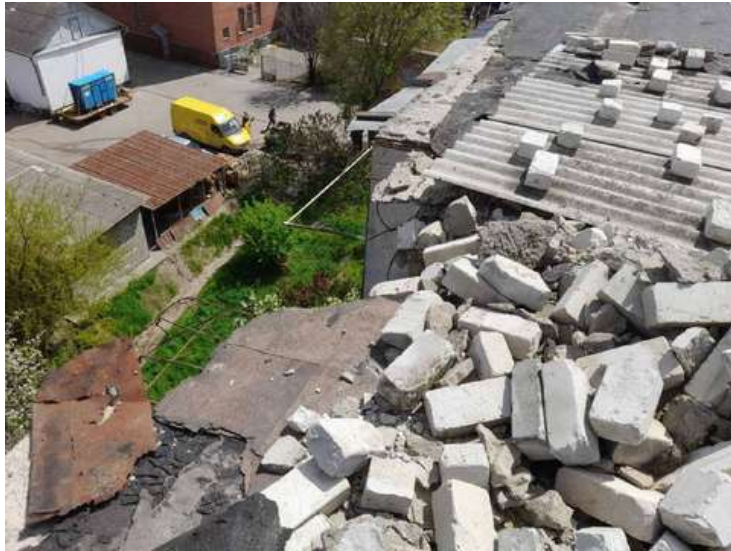
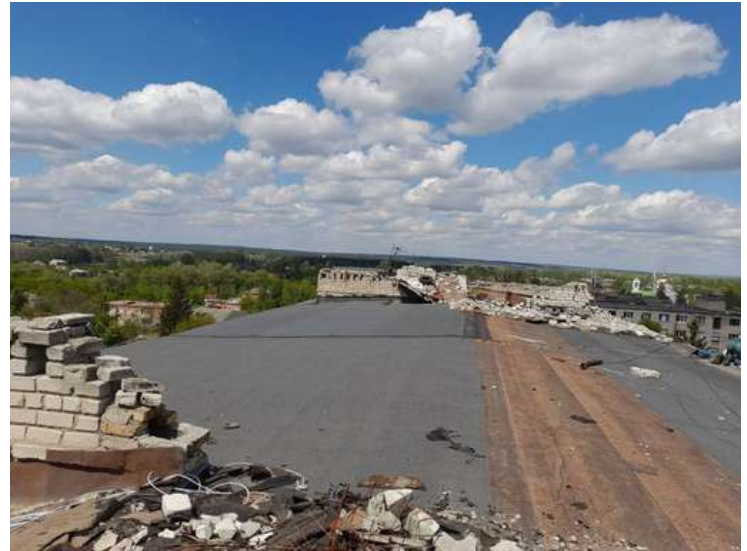
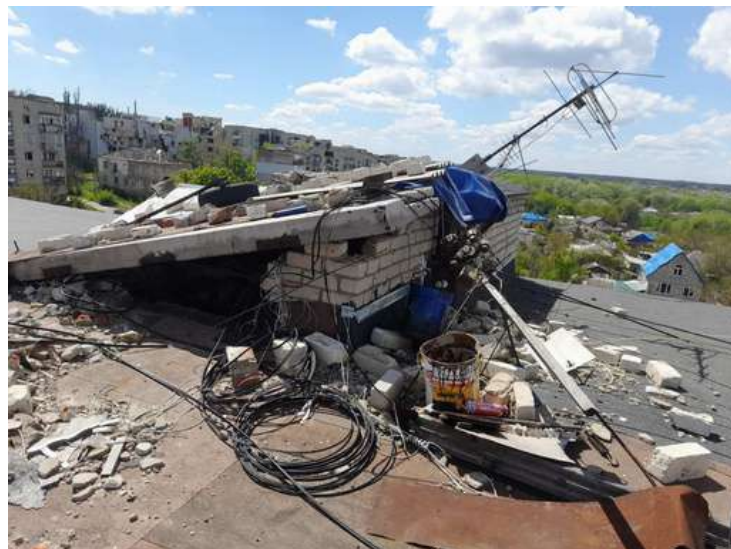
Internal walls:

- damaged partitions - 6m²

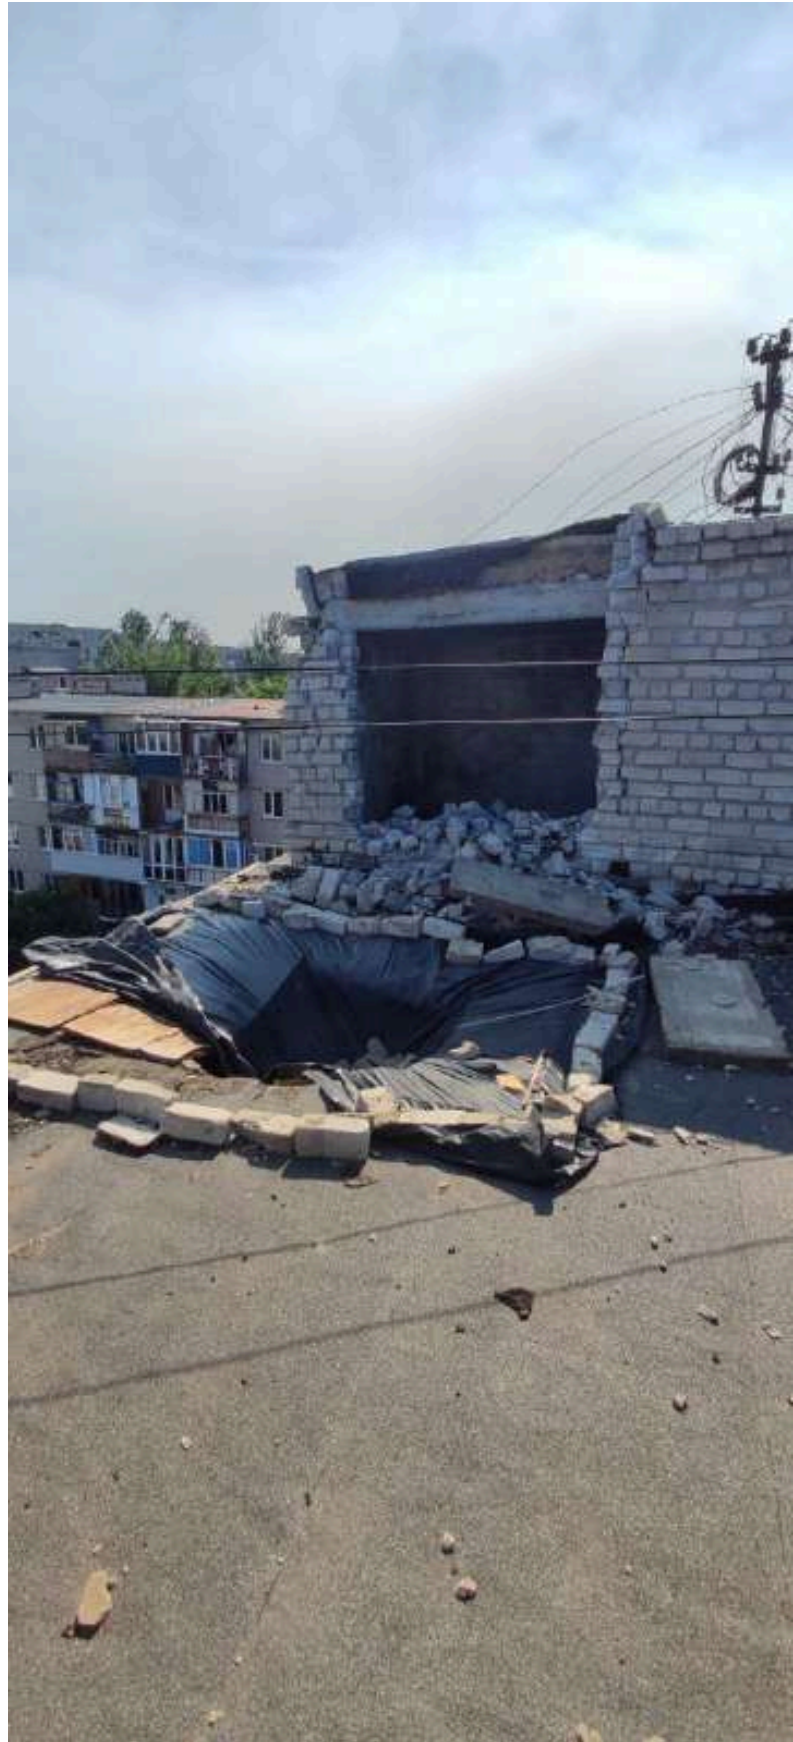
SOBORNA 18

damage to roof structures

roof area - **546.97 m²**

- approximate area of damage to roof structures - 30m²
- approximate area of damage to the outer wall (access to the roof) -10m²

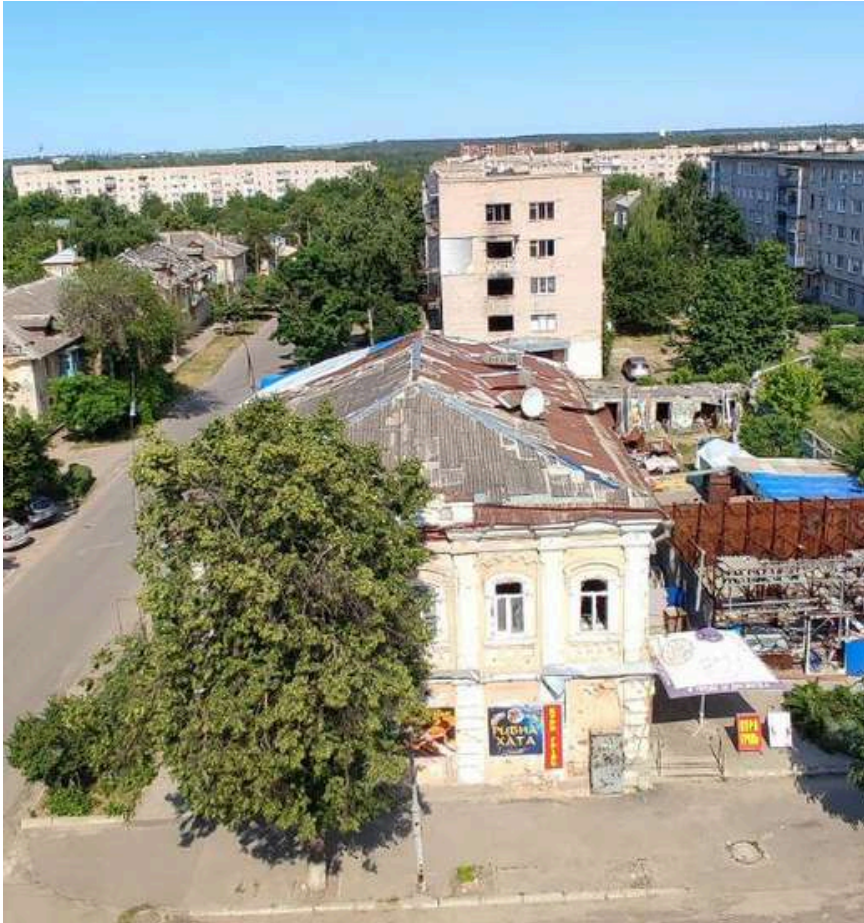
31 SOBORNA STREET

damage to roof structures

roof area -
303 m²

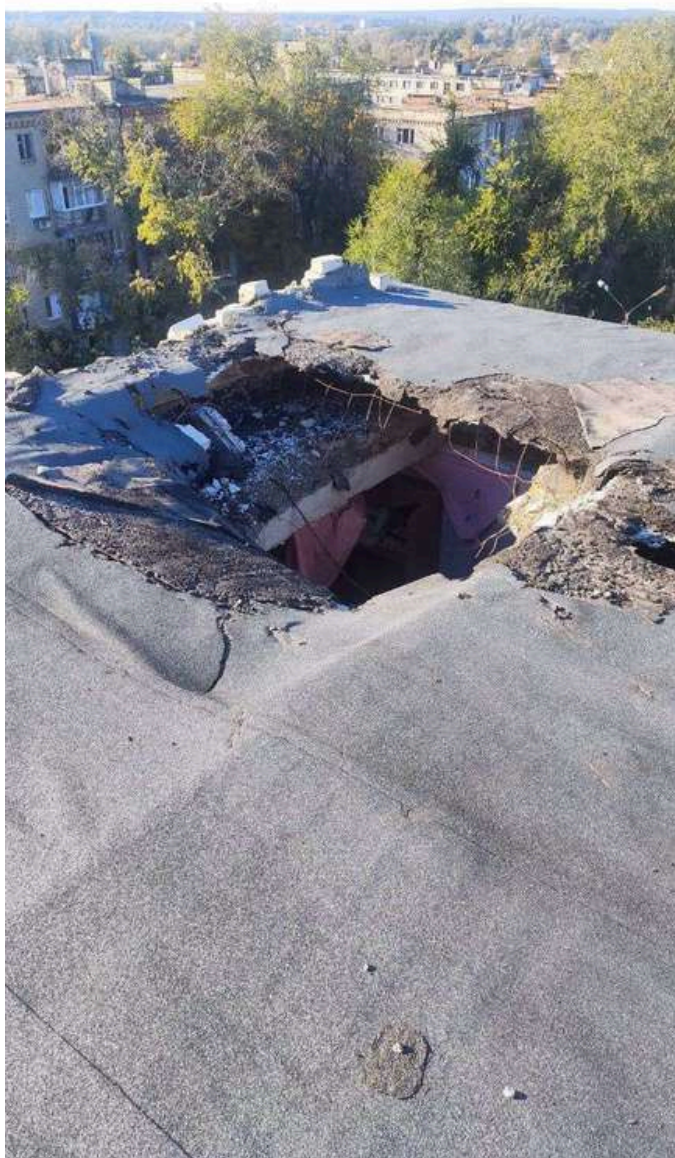
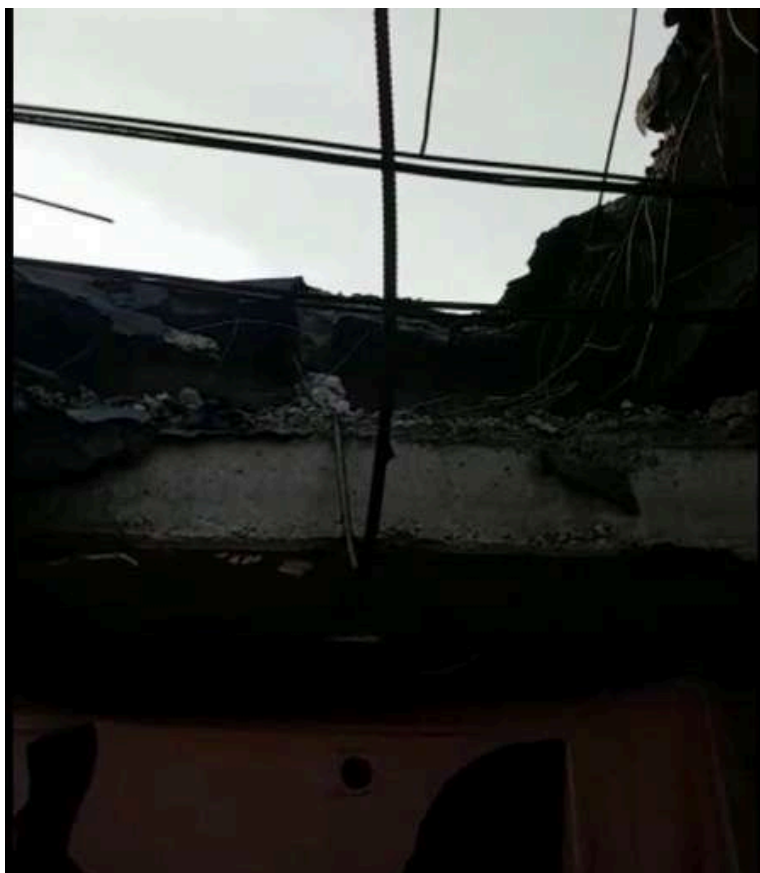
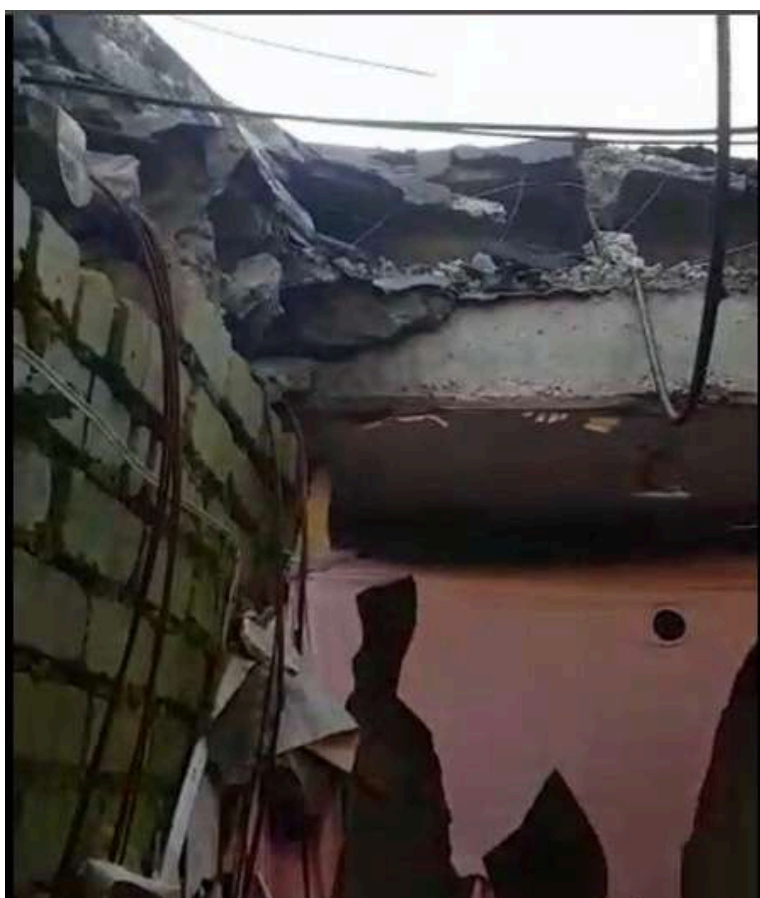
POKROVSKA 26

damage to roof structures

15 m2 of ceiling damaged
(4 floor slabs)

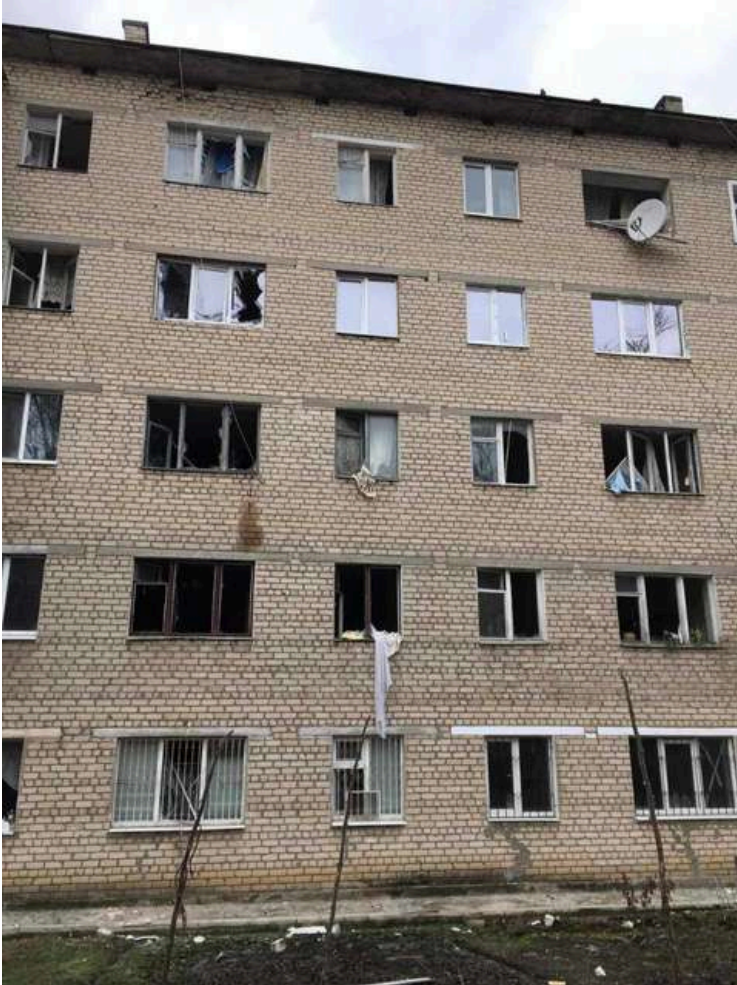
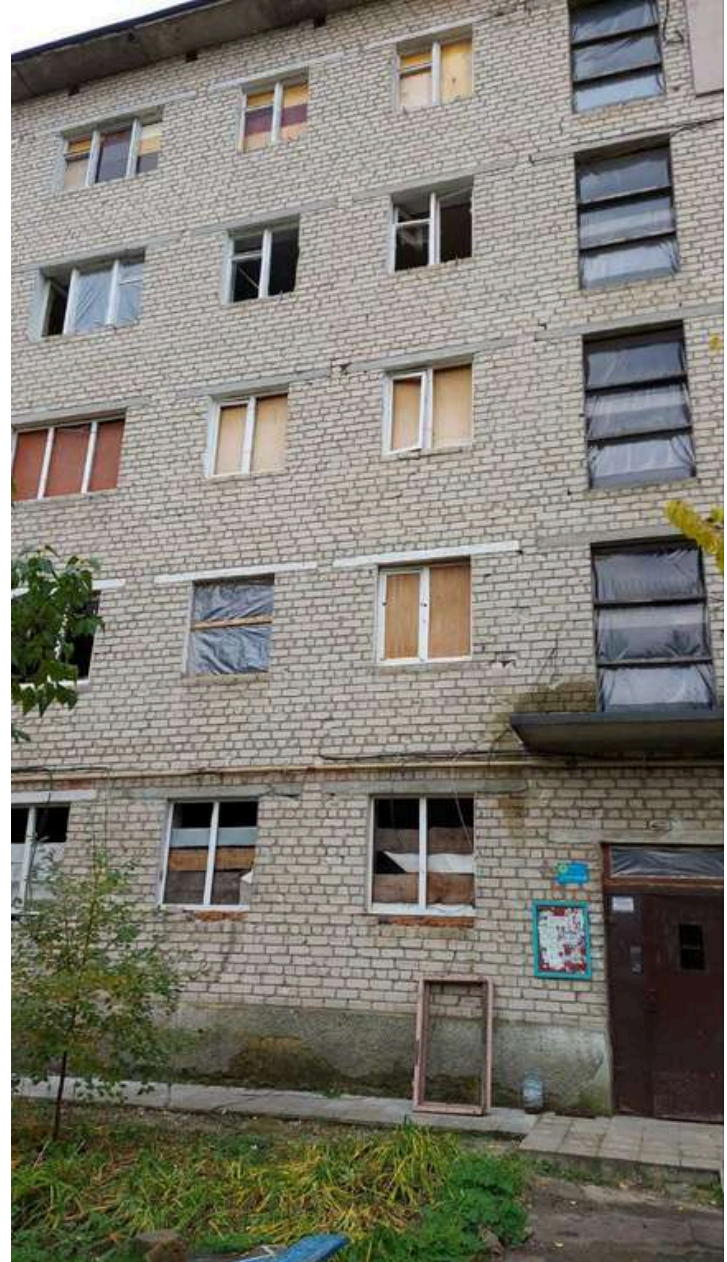
POKROVSKA 26

damage to windows

windows, type 1
(1200x1500) - 104 pcs.

windows, type 2
(1850x1500) - 60 pcs.

windows, type 3
(staircase)
(2200x1200) - 16 pcs.

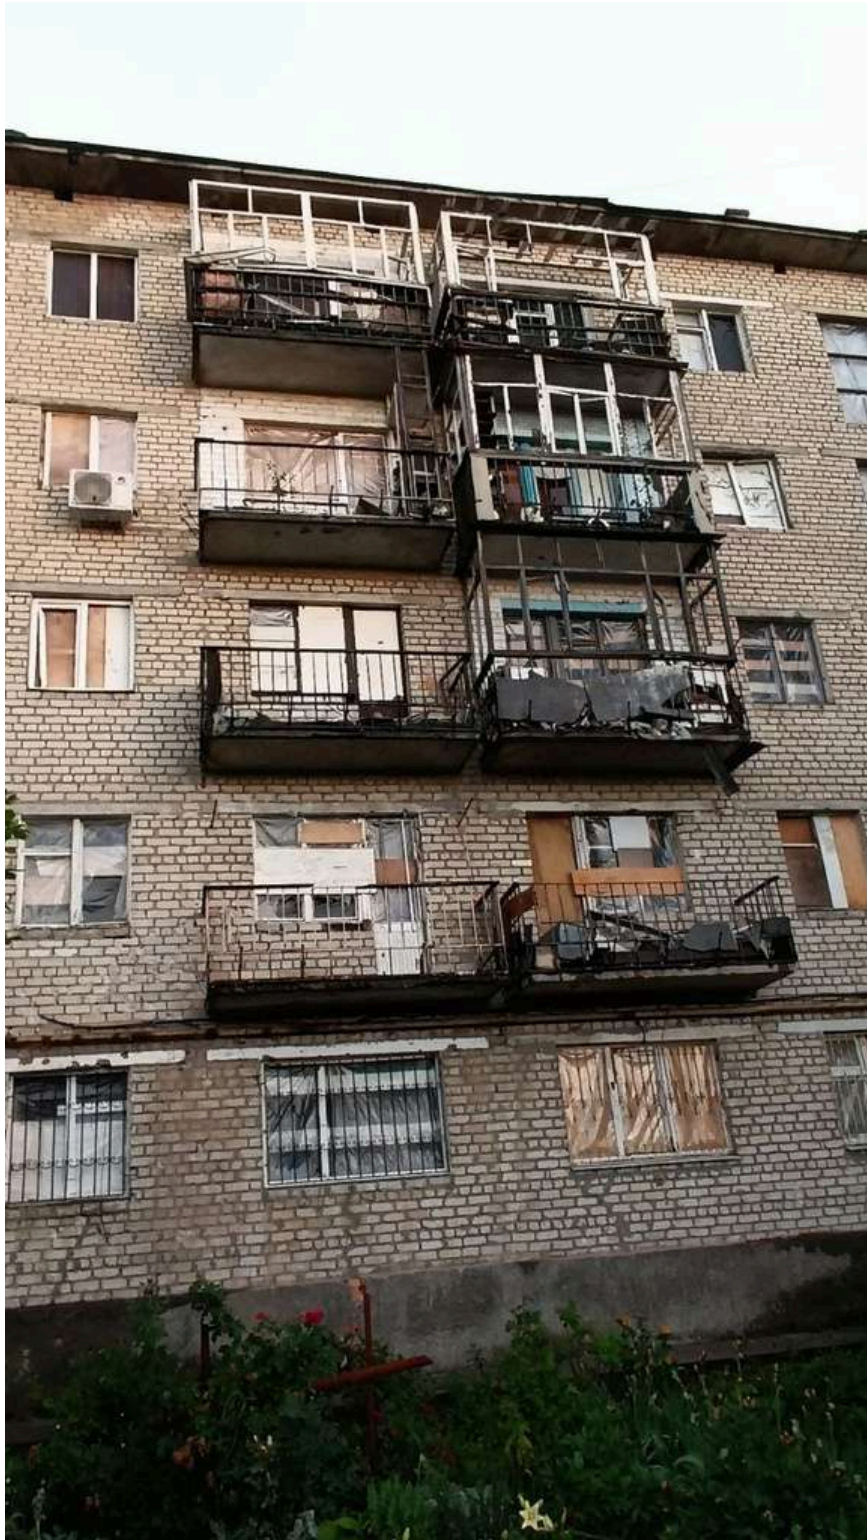
POKROVSKA 26

damage to windows

balcony unit (doors + windows) :

doors (700x2100) - 56 pcs.

windows (1500x1200) - 56 pcs.

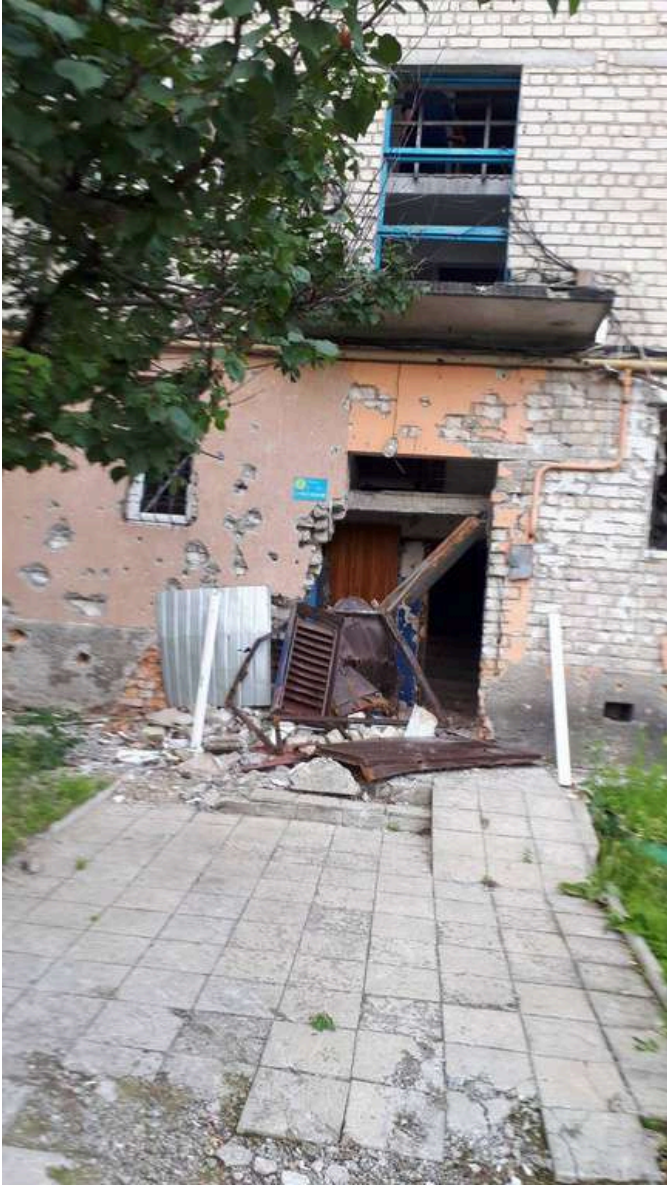
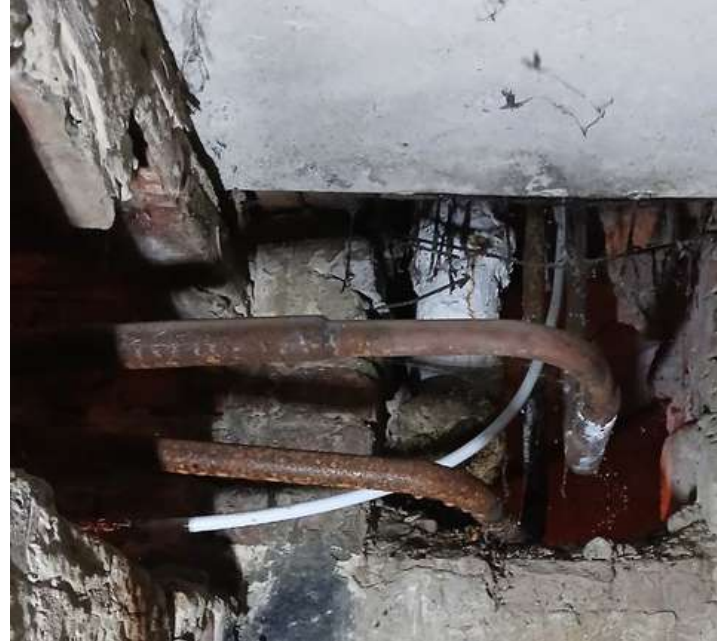
POKROVSKA 26

damage to the porch

Replacement of water risers: 240M

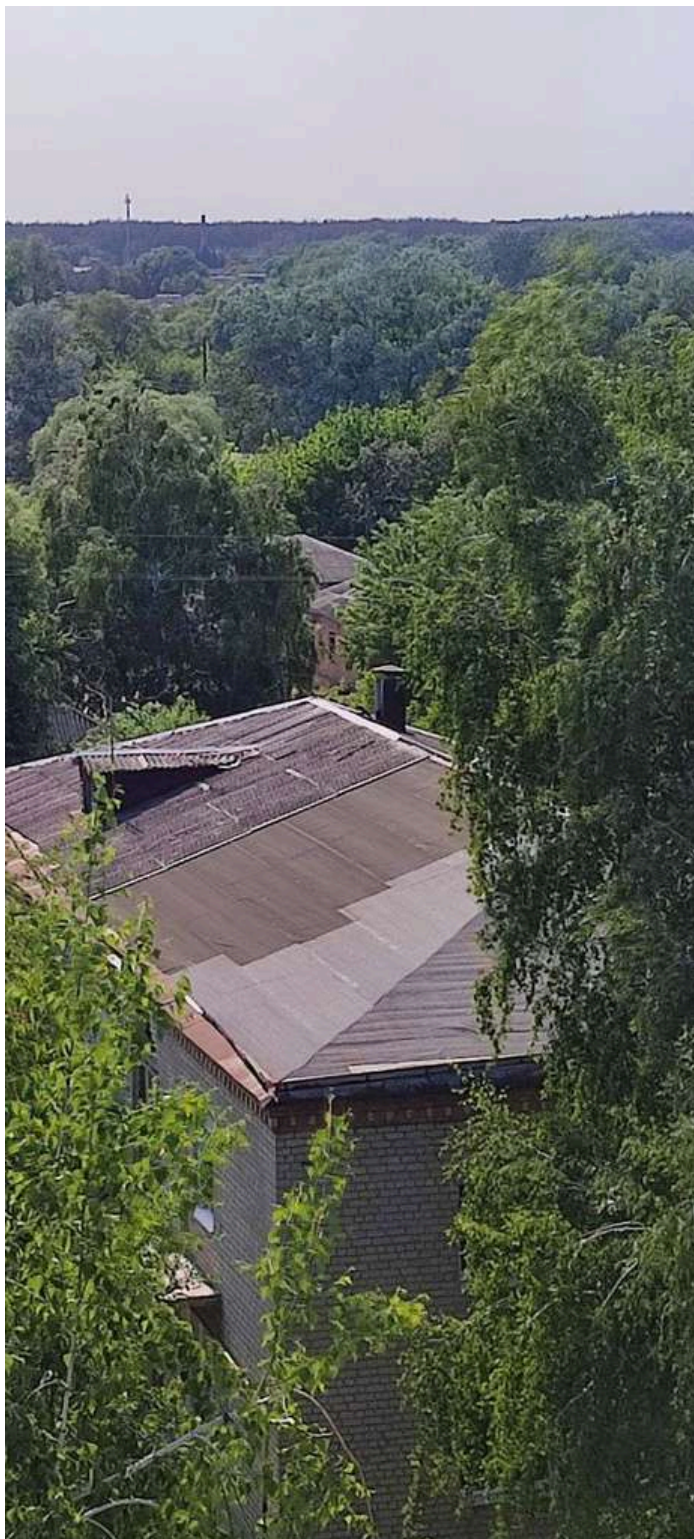
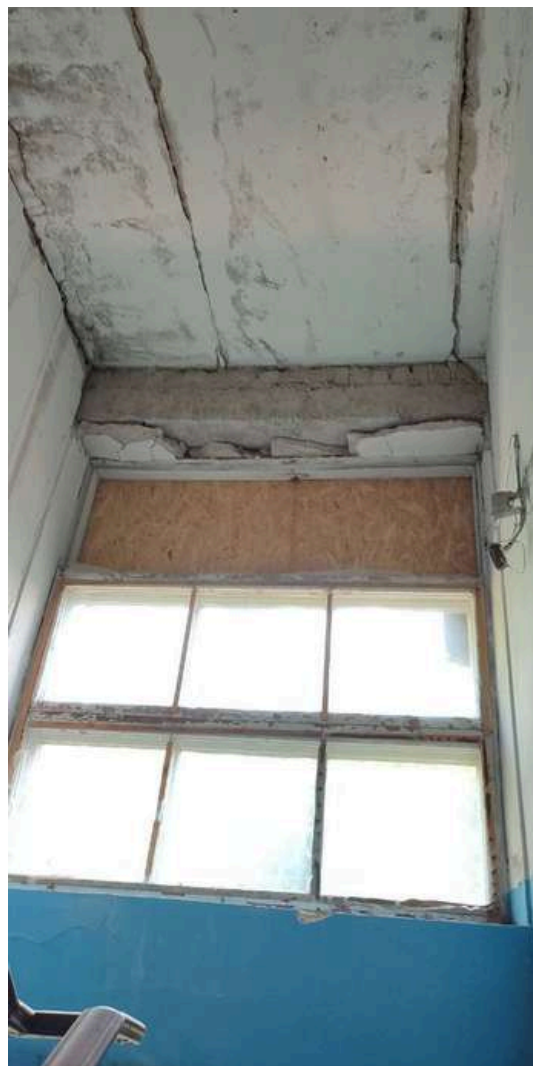
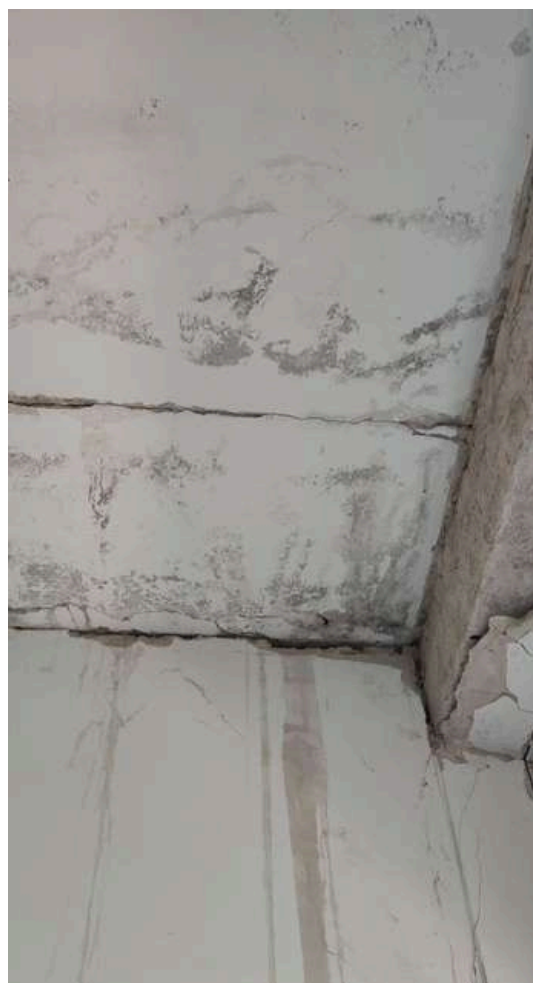
HEROES - CHERNOBYL VICTIMS 29

damage to roof structures

roof area -
394.61 m²

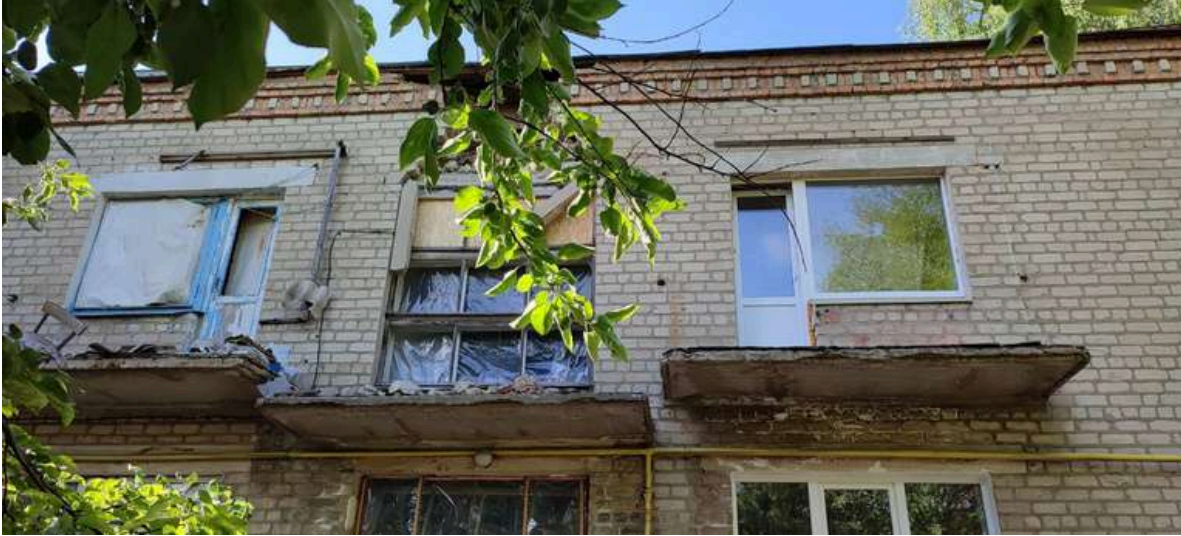
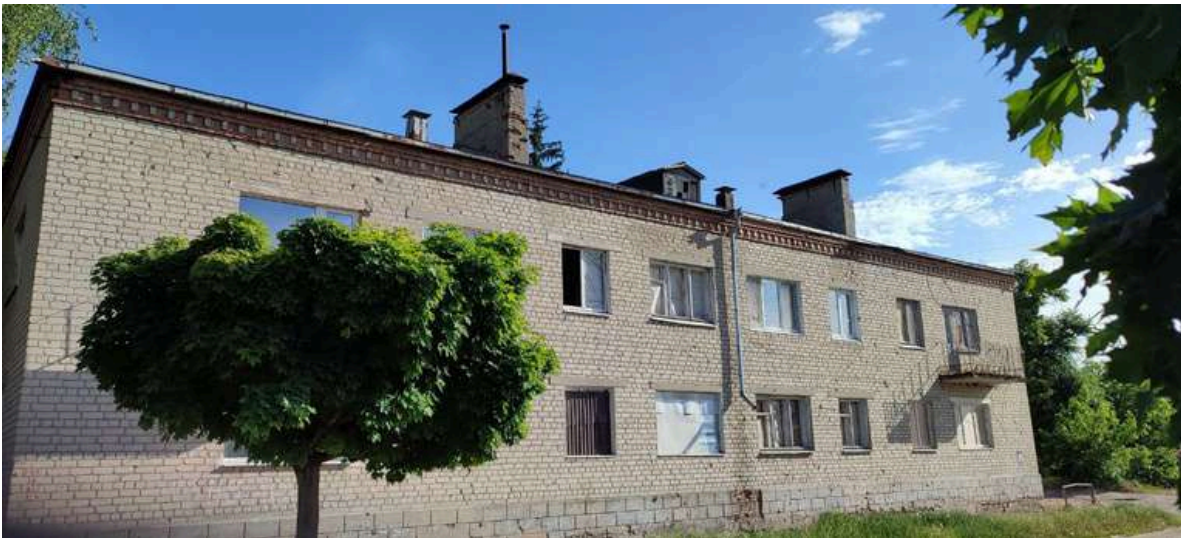
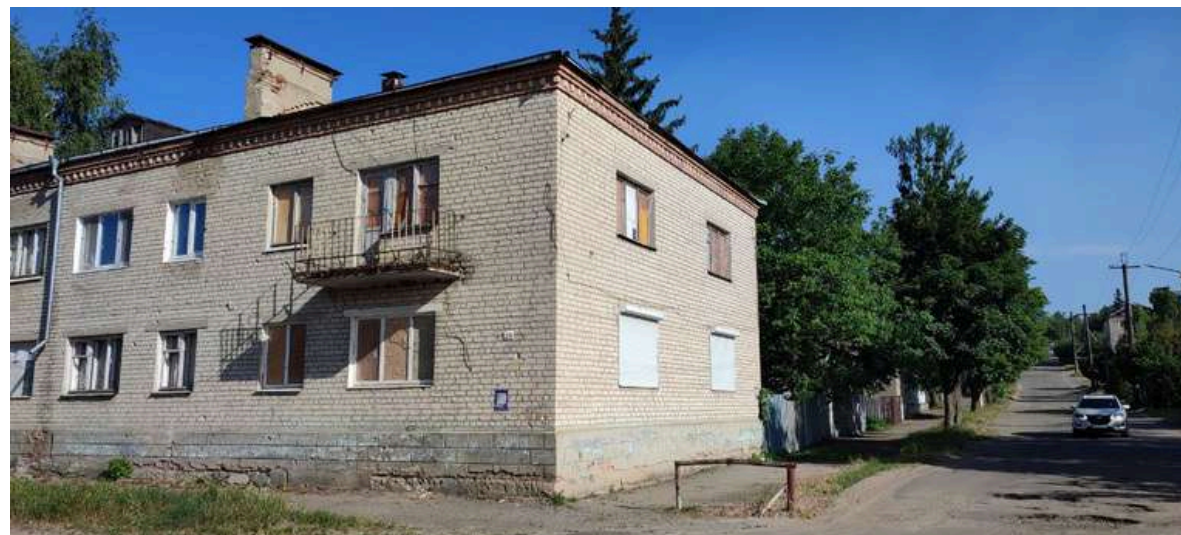
damage to windows

balcony unit:

window (1350x1350) - 6 pcs.

door (700x2100) - 6 pcs.

stained glass window

2200x2100mm

(staircase) - 2pcs

window type1 / 2500x1500- 8pcs

window type2 / 3900 x1500- 18pcs

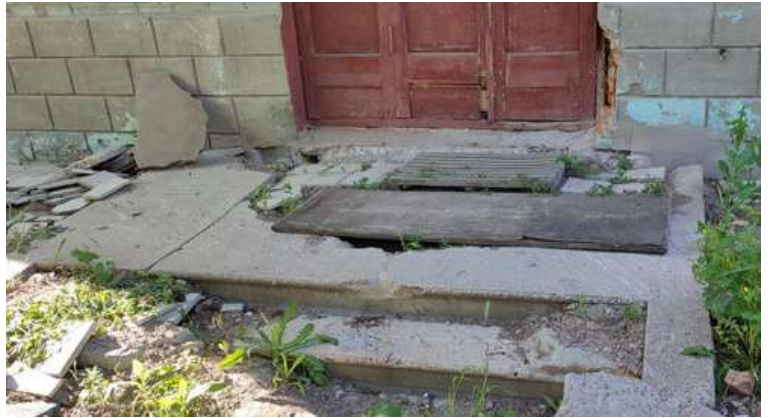
HEROES - CHERNOBYL VICTIMS 29

damage to porches

porch 1 - 2320x3520mm - 8.17m²

porch 2 - 2220x3580mm - 7.95 m²

entrance doors

(2070x3010) - 2 pcs.

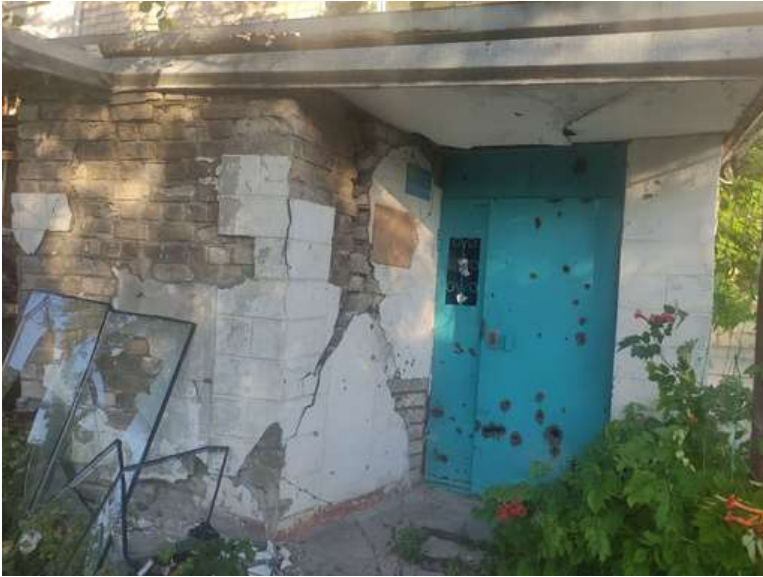
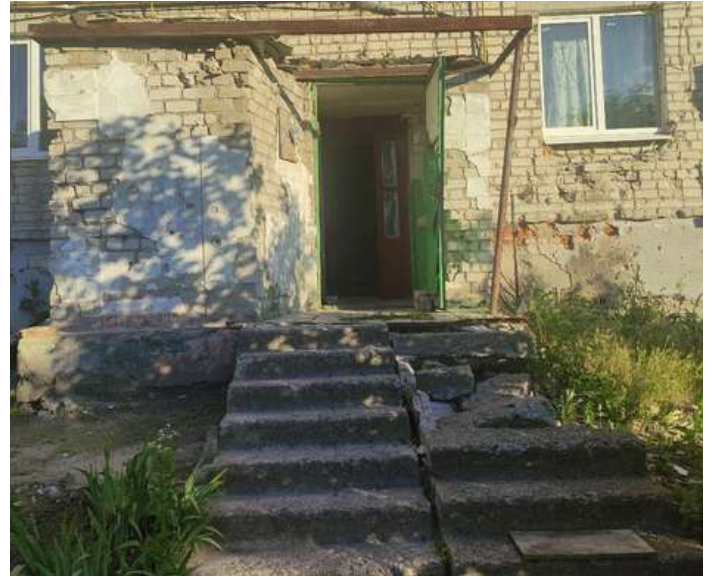
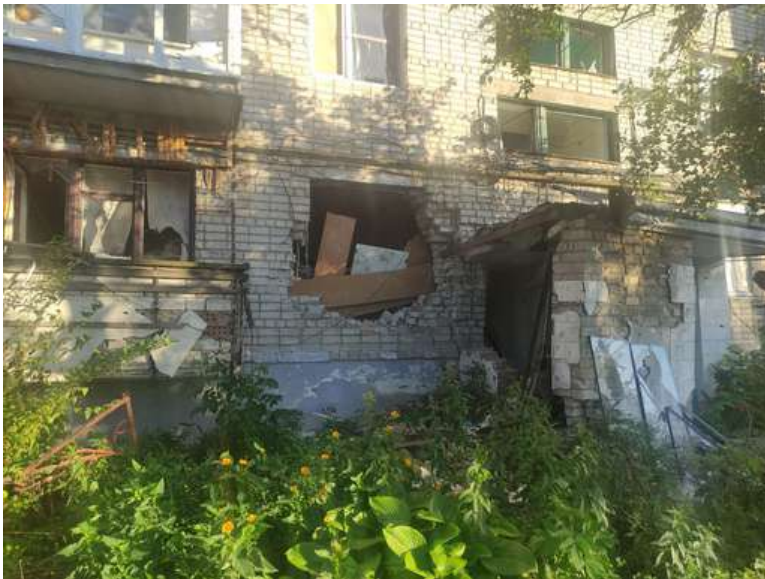
DONETS-ZAKHARZHEVSKY, 6

damage to porches

Number of damaged porches: 4

Front door (sq.m.):

- 30 sq.m. damaged.

Number of damaged windows:

- damaged - 222 units

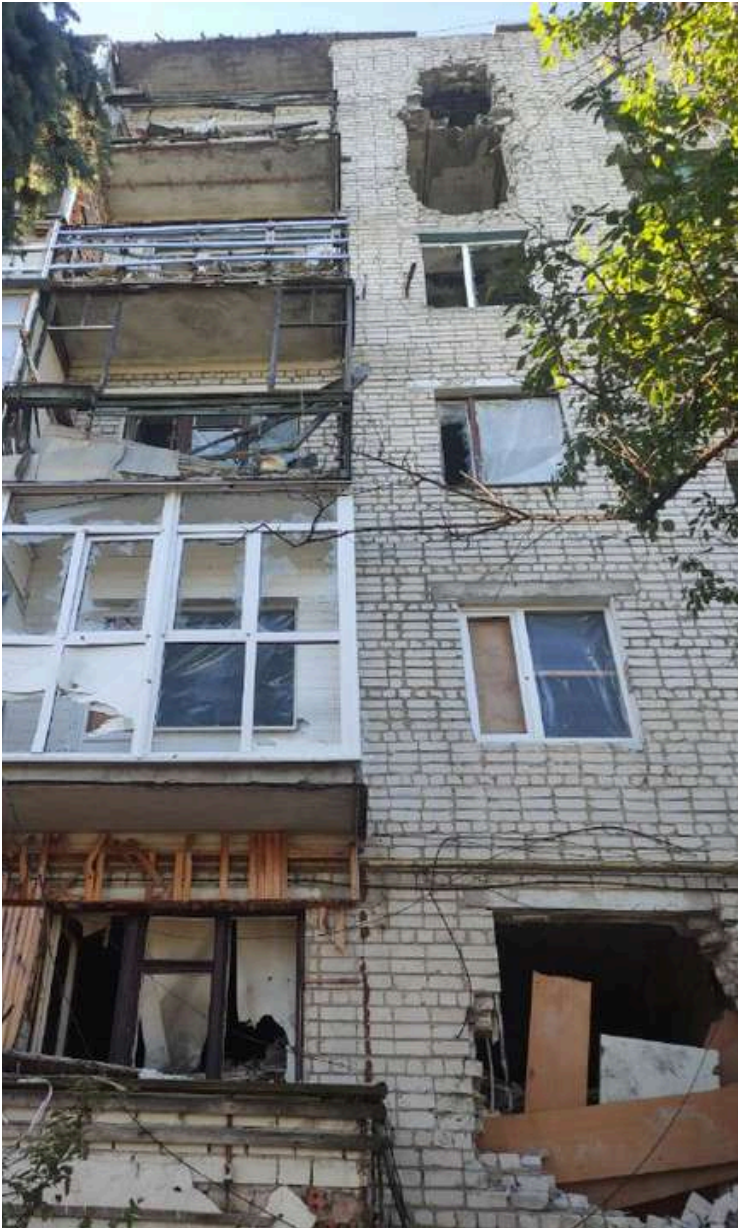
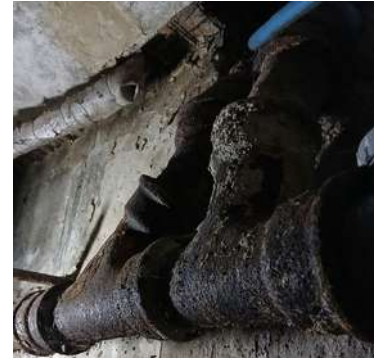
DONETS-ZAKHARZHEVSKY, 6

damage to external walls

External walls (facades):

- damaged - 160 sq m (13.3 cubic metres)

Internal walls:

- damaged - 5.5 cubic metres

Reinforced concrete structures

- damaged - 1.4 cubic metres (pavement slabs)

Replacement
of water
pipes: 150m

Replacement
of sewer
pipes: 150m

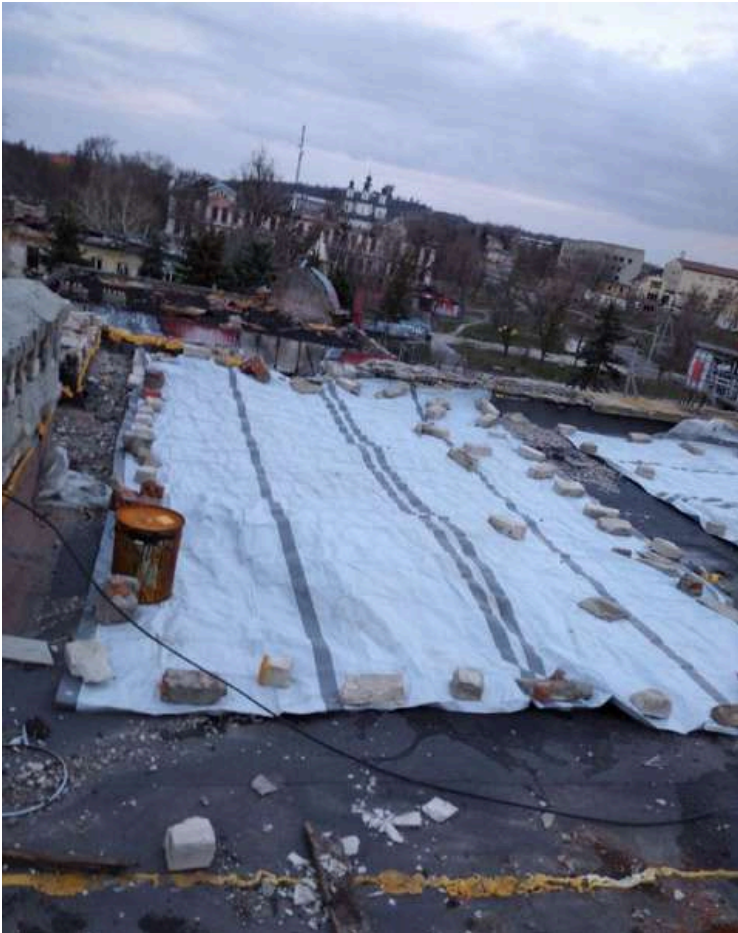
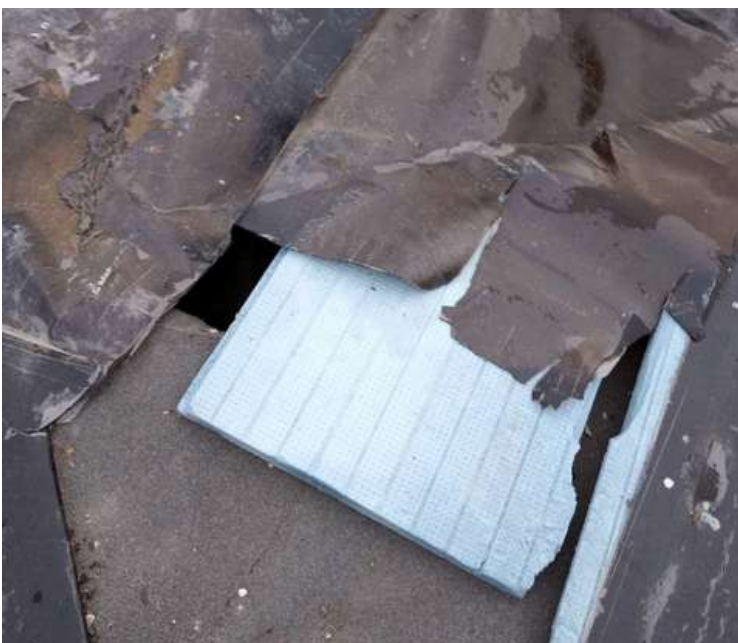
DONETS-ZAKHARZHEVSKY, 6

damage to roof structures

Roof (sq m), type of roof and type of coating:

- 120 sq m of roofing was damaged. The roofs are made of reinforced concrete slabs, and the roofs are slightly sloped.

Floor slabs:

- 13 sq.m.

Reinforced concrete structures

- damaged - 1.4 cubic metres (pavement slabs)
